HEP Project Status Report – April 2019
Large Synoptic Survey Telescope (LSST) Camera

HOST LABORATORY: SLAC
 PROJECT MANAGEMENT EXECUTIVE: Steve Binkley
 CONTRACTOR PROJECT MANAGER: Vincent Riot

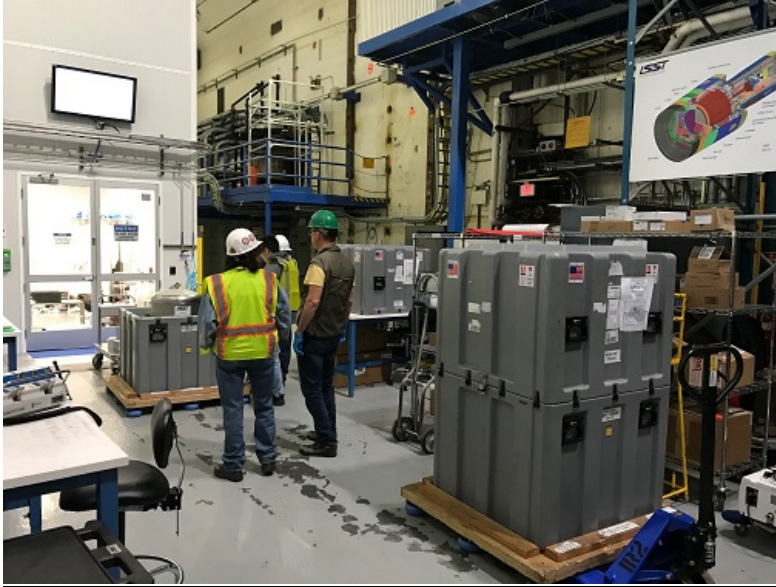
Figure 1: Receiving RTM17 and RTMN22 at the SLAC IR2 Cleanroom Facility in early April. Near the door, the top half of one container was removed, showing the bell-jar that holds one RTM during shipment. At right, a second container sits unopened on a pallet. Thus far, BNL has delivered five refurbished RTMs to I&T for re-verification.

As RTMs are cleaned, upgraded and reassembled, they will be delivered to I&T for reverification at IR2. Thus far, five RTMs have been delivered to I&T and are undergoing re-verification or are in queue for it.

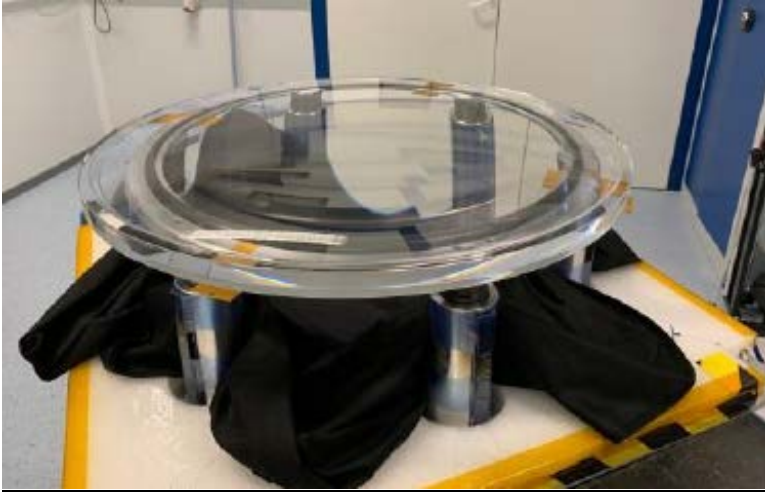
Figure 3: REOSC successively completed Broadband Anti-Reflective (BBAR) coating of the L3 lens and returned L3 to Thales SESO (TSESO) for inspection. The Optics team determined the lens meets project requirements.

Thales SESO (TSESO) completed final inspection of the L3 lens following Broadband Anti-Reflective (BBAR) coating (Figure 3). The lens meets project requirements. TSESO received the L3 barrel from the painting vendor and has begun the process of integration of L3 with the barrel, which is going well (Figures 4 and 5). The barrel will surround L3 and provide attachment to the cryostat housing.

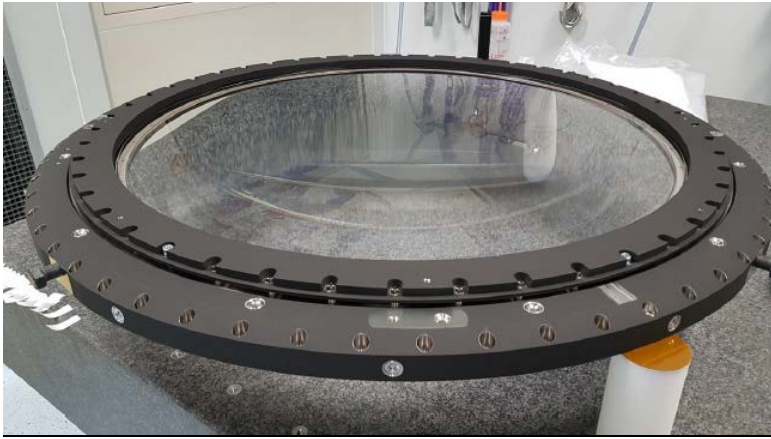
Figure 5: Early stages of integration of the L3 lens with its barrel. Here, the front side of the barrel is shown. The barrel is also called the cryostat front flange.

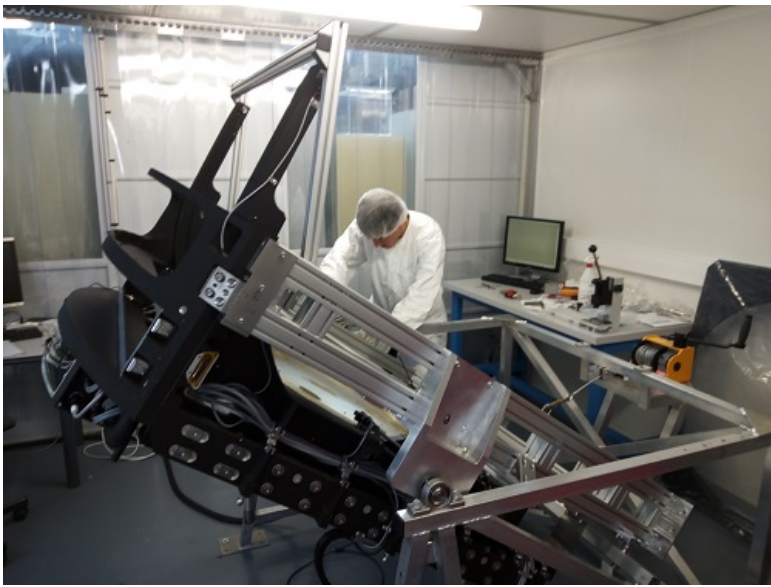
Figure 6: At CPPM, testing for the first unit auto-changer on its standalone test bench. Here the auto-changer is oriented at 45 degrees to the horizontal. On the Camera, the auto-changer can be used to swap a filter from online position in front of the L3 lens to one of the five storage positions on the filter carousel.

- **Filter Exchange.** The Filter-Exchange team in France continued construction of production components. As reported, CPPM completed the assembly of the first of two auto-changers, and testing of the first unit is well-underway (Figures 6 and 7). CPPM also completed procurement of parts for the second unit.

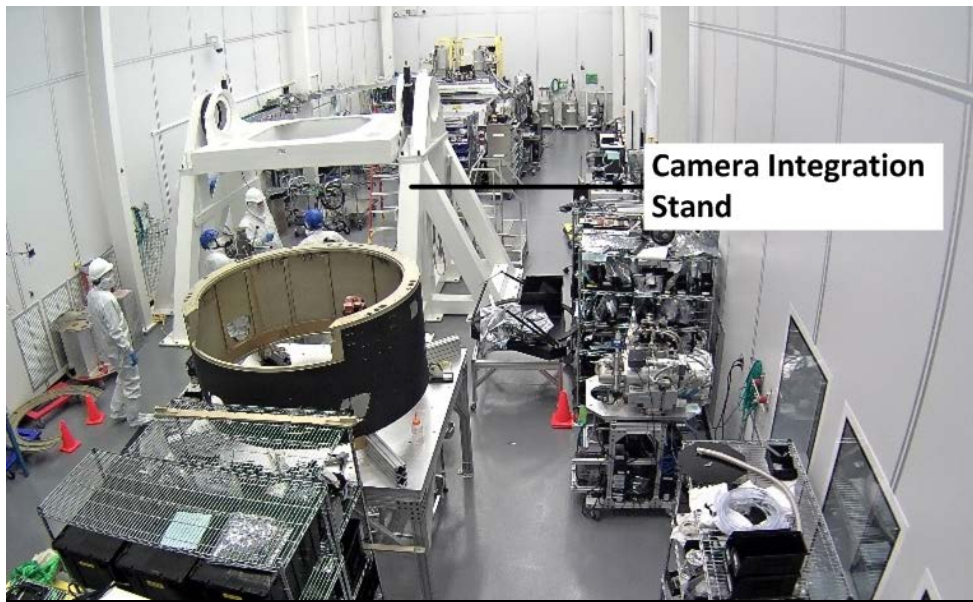
Figure 11: A recent view of the IR2 main area facing south (opposite the view in Figure 10). In the foreground, the cryostat housing sits on an assembly work bench. Beyond that, technicians work on assembly of the Camera integration stand. The integration stand will cradle the Camera during construction.

Assembly of the Camera integration stand is underway at IR2 (Figure 11). The stand will cradle the Camera during construction. Piers for the two sides of the stand were leveled and holes were drilled for attachment to the floor. The cradle that sits on the main weldment was assembled outside IR2 and moved into place. An interface plate that will attach the cradle to the Camera rotator was fit-checked and sent for final modifications.
